JOINT TASK FORCE ONE

ARMY GROUND GROUP
(TASK GROUP 1.4)

FINAL REPORT

ATOMIC BOMB TESTS

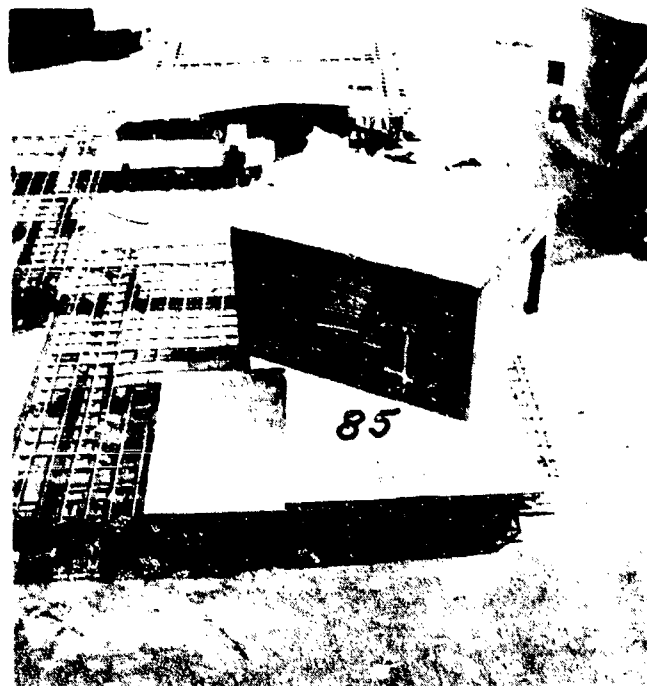
d. Motor, Rocket, 2.25", MK3 (Navy) (Item #85). Seven motors were displayed in a wood box, Fig. 367. On the YOG 83, the rear end, right side, and top were scorched and the markings were obliterated. The box was moved 1" by the blast. On the LST 52, Fig. 368, the box was scorched on the blast side and the box was moved 20" with the blast. The tie-down straps had been broken. On the LST 661, the box was scorched on the side directly exposed to the blast. The markings on that side were obliterated. No damage was apparent on the LSTs 220 and 545.

Fig. 368 - LST C2 - Damage to Item 85 after Test Able.

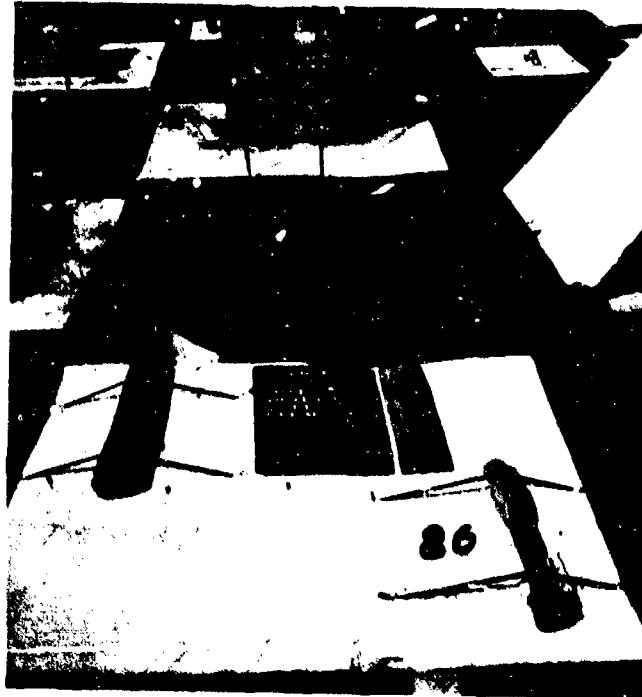
Fig. 369 - LST 661 - Method of securing Item 86.

e. Rocket, Practice, AT, 2.36", M7A3 (Item #86). One rocket was displayed bare, Fig. 369. On the YOG 83, Fig. 286 and Fig. 370, the motor tube was scorched and rusted. The tape around the safety pin had been blown away. The head was slightly scorched and rusted in one spot on the side toward the bomb blast. The white.

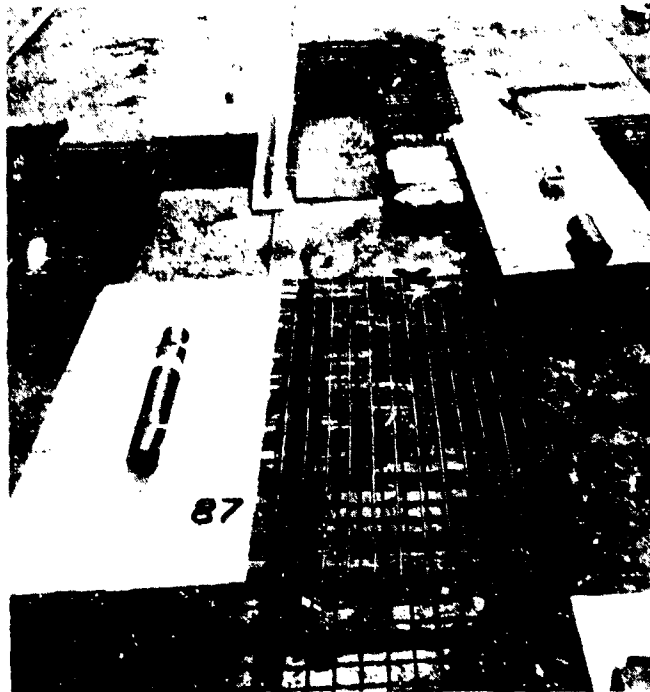
Fig. 371 - LST 52 - Method of securing Item 87.

f. Rocket, Practice, AT, 2.36", M7A3 (Item #87). One rocket was displayed in a fiber container, Fig. 371. On the YOG 83, Fig. 372 and Fig. 373, the container was moved to the left 3-1/2" by the blast. Two layers of fiber paper were torn and scorched on the side facing the blast. The exposed end of the container was devoid of paint. A section of the tape containing part of the nomenclature was torn from the side facing the blast. On the side away from the blast the tape was intact and the marking was legible. On the LST 52, Fig. 374, the fiber container was scorched on the blast side and dented by the straps. The item is serviceable but the markings were obliterated. No damage was apparent on the other ships.

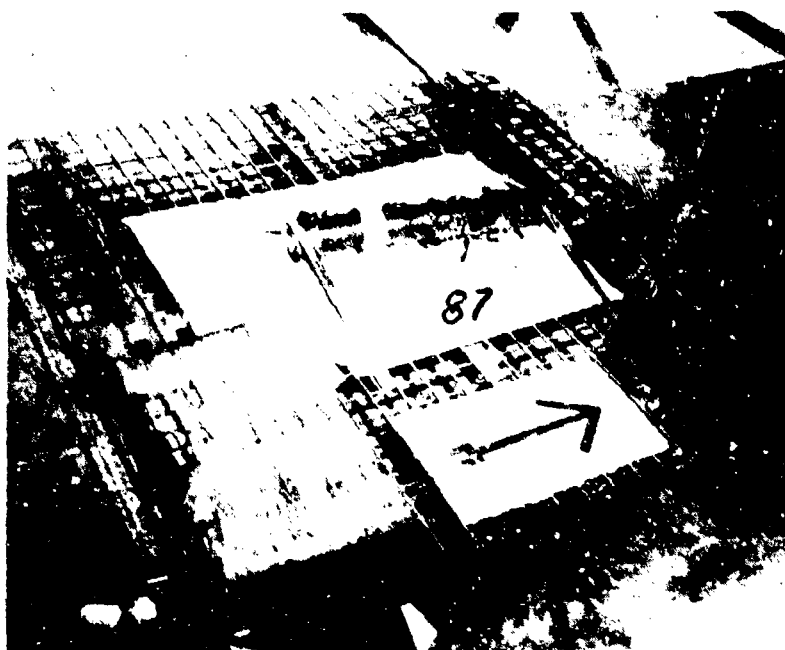
Fig. 373 - YOG 83 - Damage to Item 87 after Test Able.

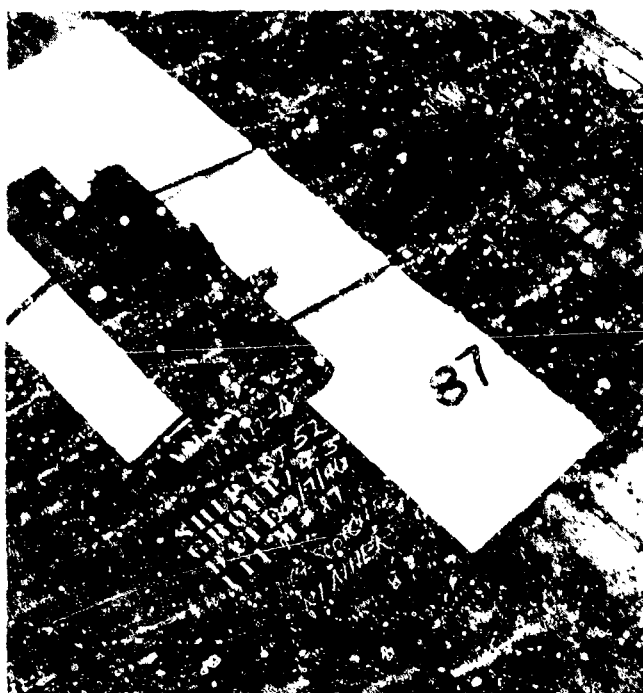
Fig. 374 - YST 53 - Damage to Item 87
after Test Able.

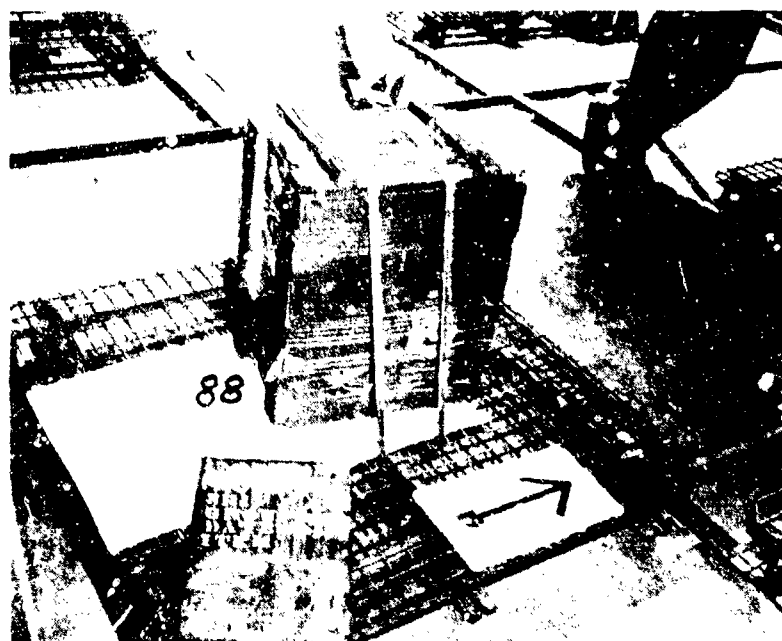
g. Rocket, Practice, AT, 2.36", M7A3 (Item #88). Eighteen were displayed in a wood box, Fig. 334. On the YOG 83, Fig. 321 and Fig. 375, the box was moved 4" by the blast. The top was pushed forward 1" more than the bottom so that the box resembled a parallelogram. The nails holding the box together were bent. The nomenclature on the side and end was obliterated by scorching but that on the top was only partially obliterated. On the LSTs 52 and 661, the box was scorched on the blast side but was serviceable. No damage was apparent on the remaining LSTs.

Fig. 375 - YOG 83 - Damage to Item 88 after Test Able.

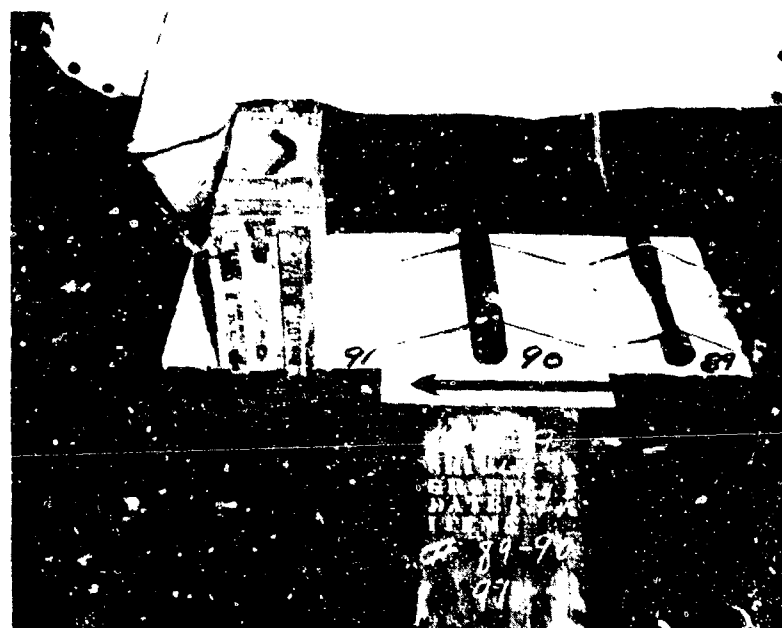
Fig. 376 - LST 52 - Method of securing Items 89, 90, and 91.

h. Rocket, HE, AT, 2.36", M6A3F (Item #89). One Rocket was displayed here, Fig. 376. On the YOG 83, before the test, the stabilizer tube threads were rusty. After the test, the fins were rusted both inside and out. The stencilling was slightly scorched. On the LST 52, the item was unserviceable, because of shroud denting caused in strapping the rocket to the pallet. The rocket was partially masked from the blast by a ladder. No further damage resulted. No damage was apparent on any of the other ships.

i. Rocket, HE, AT, 3.36", M6A3F (Item #90). One round was displayed in a fiber container, Fig. 376. On the YOG 83, Fig. 377 and Fig. 378, the fiber container was scorched and peeled. The sealing tape had a slight tear but the nomenclature was legible. On the LST 52, the container was dented by the strapping. It was partially masked by a ladder. The item was scorched on the LST 661. No damage was apparent on the remaining ships.

j. Rocket, HE, AT, 2.36", M6A3F (Item #91). Six of these rockets were displayed in a wood box, Fig. 376. On the YOG 83, there was a slight scorching on one side, the end cleats, and top cleats of the box. The end cleats were also split. The unexposed sides had been splattered with asbestos matting. The box was moved 1" by the blast. On the LST 52, the item was masked partially by a Jacob's ladder and no damage resulted. On the LST 661, the box was slightly scorched but the markings were still legible. No damage was apparent on the remaining ships.

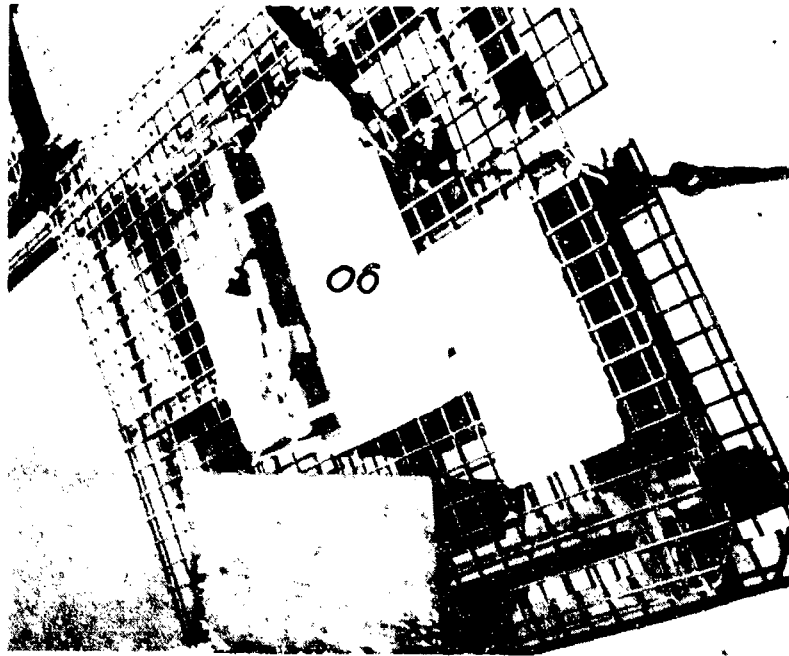
Fig. 378 - YOG 83 - Damage to Item 90 after Test Able.

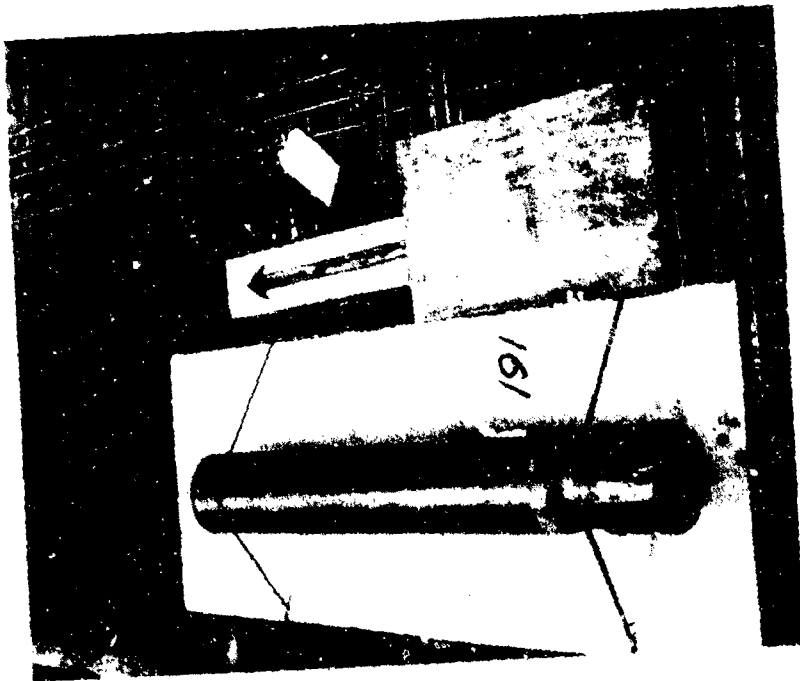
Fig. 380 - LST 661 - Method of securing
Item 191.

l. Rocket, Practice, 4.5", M17SS (Item #191). One rocket was displayed in a metal container, Fig. 380. On the YOG 83, there was a slight scorching on the right side. The AIC code had been obliterated. Otherwise, the markings were legible. No damage was reported on the other ships.

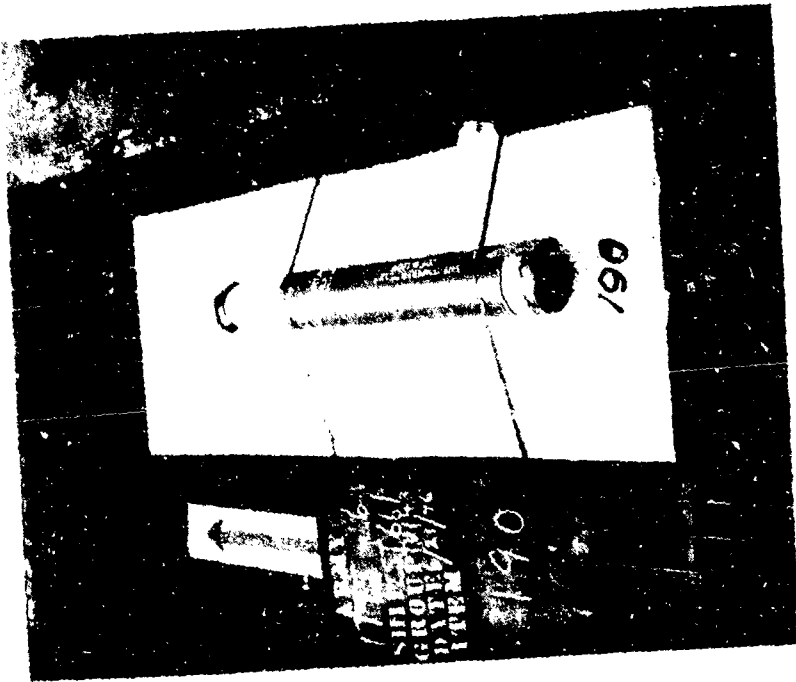
Fig. 379 - LST 661 - Method of securing
Item 190.

k. Rocket, Practice, 4.5", M17SS (Item #190). One round was displayed bare Fig. 379. On the YOG 83, the right front of the ogive was scorched. The right rear body was also scorched slightly. The tape holding the closing cap in place was parted. The closure cap was scorched and badly warped. On the LST 52, before Test Able, the closure cap was loose. After Test Able the tape on the shorting strap was scorched. No damage was apparent on the other ships.

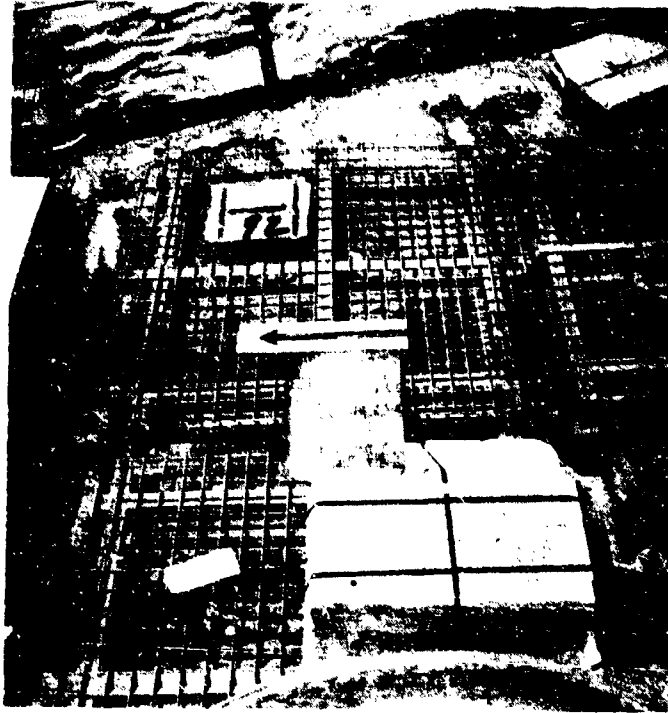
Fig. 381 - LST 661 - Method of securing Item 92.

a. Fusee, Red, M72 (Item #92). One fusee was displayed bare, see Fig. 381. There was no visible damage to the item masked by the wheel house on the YOG 83. On the LST 52, the item was partially masked and there was no damage. On the remaining ships no change was apparent.

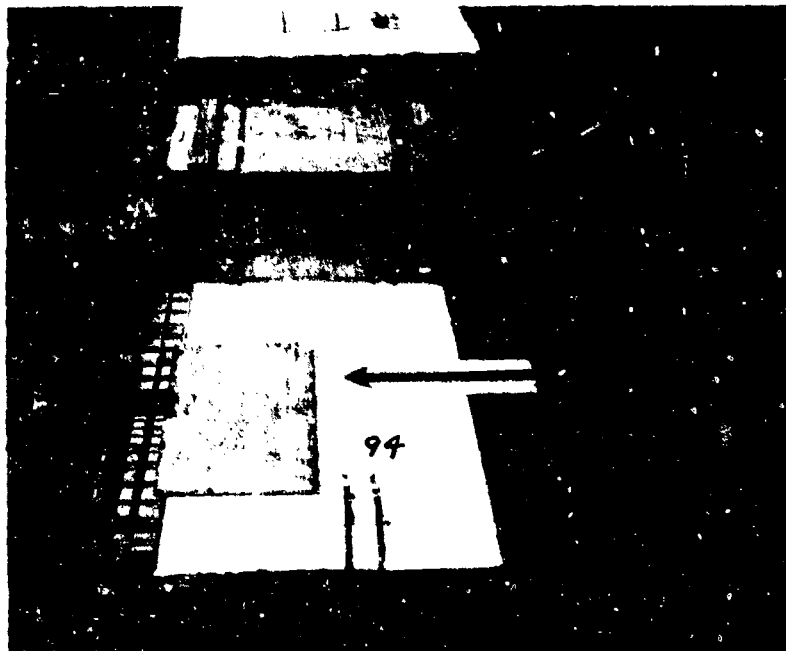
Fig. 383 - LST 83 - Method of securing Item 94.

c. Signal Aircraft, AN-M53 (Item #94). One signal was displayed bare, see Fig. 383. On the YOG 83, see Fig. 271 and Fig. 384, the closing crimp opened from exposure. Slight scorching over an area of 1/2" x 2-1/2" on the side of the signal case obliterated some of

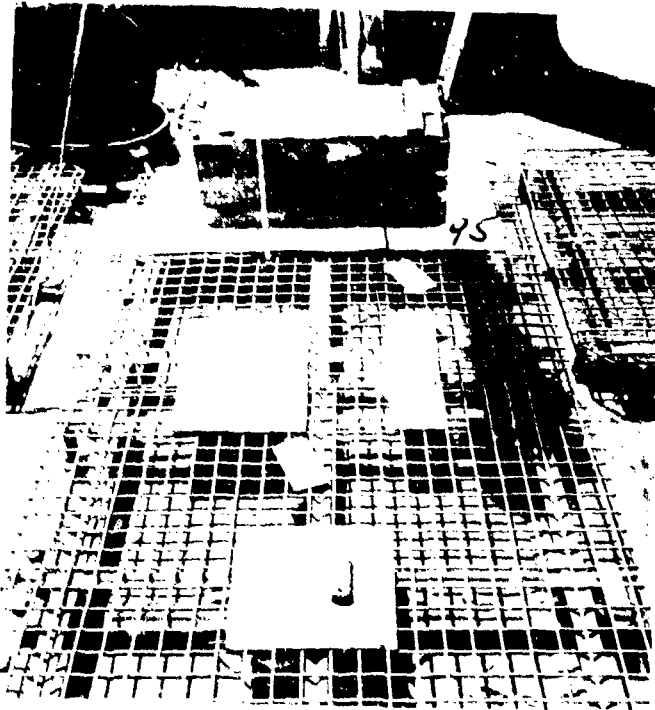
Fig. 385 - LST 661 - Method of securing
Item 95.

d. Signal, Aircraft, AN-M53 (Item #95). One hundred thirty two signals were displayed in a box; see Fig. 385. On the YOG 83, see Fig. 276 and Fig. 386, the box was charred heavily by heat on the side, end, and part of the top. The markings were not legible. The wax was melted on the cardboard cartons inside the box. Heat from the combustion of the nearby 155mm propelling charges is believed to have caused this latter damage. On the LST 52, see Fig. 387, the box was charred; the charring was attributed to the burning of the 155mm propelling charges 4 feet away. The parts charred were those facing the blast on the top and sides. On the LST 661, the box was slightly scorched, but the markings were still legible. No damage was apparent on the remaining ships.

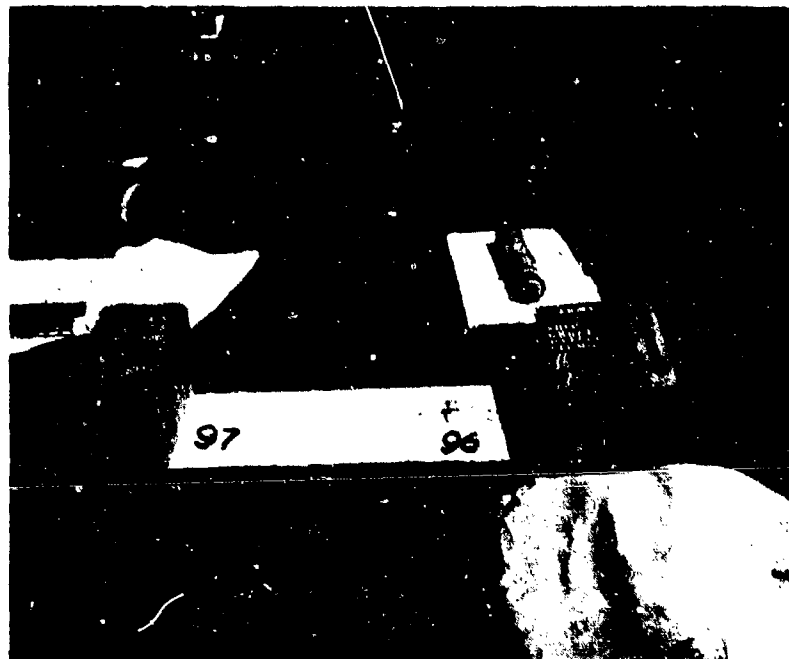
Fig. 388 - LST 52 - Method of securing Items
96 and 97.

e. Signal, Ground, High Burst, Ranging, M27 (Item #96). One was displayed bare, see Fig. 388. On the YOG 83, the nomenclature was obliterated by exposure to rain. No primary damage was sustained, as the item was shielded by the boat deck. No damage resulted on any of the other ships.

f. Signal, Ground, High Burst, Ranging, M27 (Item #97). Ninety-eight were displayed in a wood box, see Fig. 388. On the YOG 83, see Fig. 271 and Fig. 383, the box was charred by the heat from the combustion of the 155mm propelling charges. The forward two thirds of the side ranges from slight scorching to charring. The rest of the box was unchanged but it was moved 1/3" from its original position. On the LST 52, the box was charred and scorched on the side and top. This charring was attributed to the burning of the 155mm propelling charges 6 feet away. No other damage was sustained. On the LST 661, the box was slightly scorched but the markings were still legible. On the remaining LSTs there was no damage apparent.

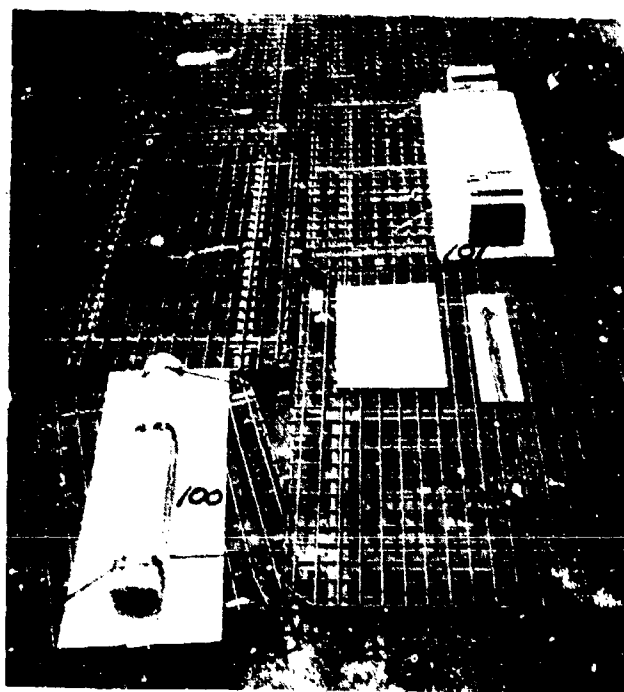
Fig. 390 - LST 661 - Method of securing Items 100 and 101.

h. Flare, Airport, T15 (Item #100). One flare was displayed bare, see Fig. 390. On the LST 52, the flare

body was slightly scorched on the blast side and the legs were parted from the flare body. On the YOG 83, the item was masked and suffered no damage. There was no apparent damage to the other ships.

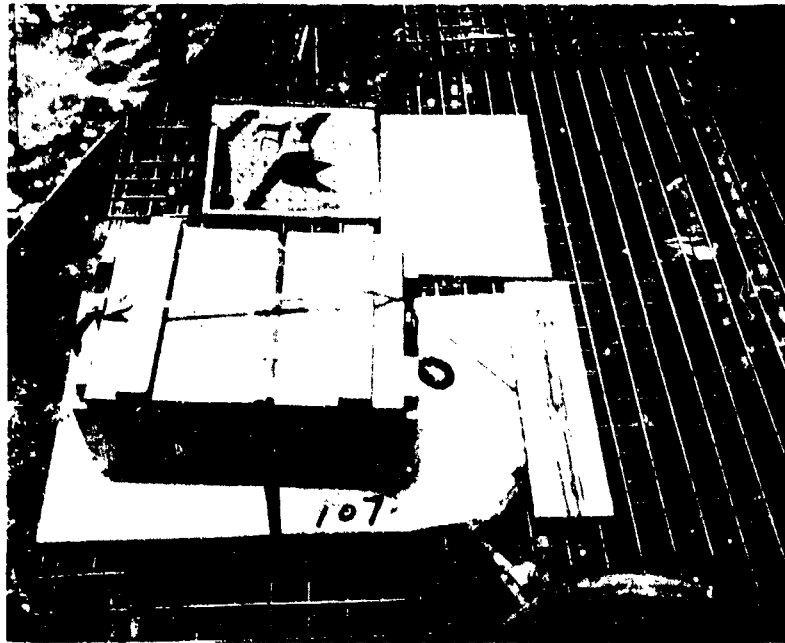
Fig. 395 - LST 661 - Method of displaying Item 107.

2. Flare, Trip, M49 (Item #107). Fifteen flares were displayed in a wood box, see Fig. 395. On the LST 52, the box was slightly scorched on the side towards the bomb. No damage, on the YOG 83, was noted because of masking of the item by the bomb deck. There was no apparent damage to the item on the other ships.

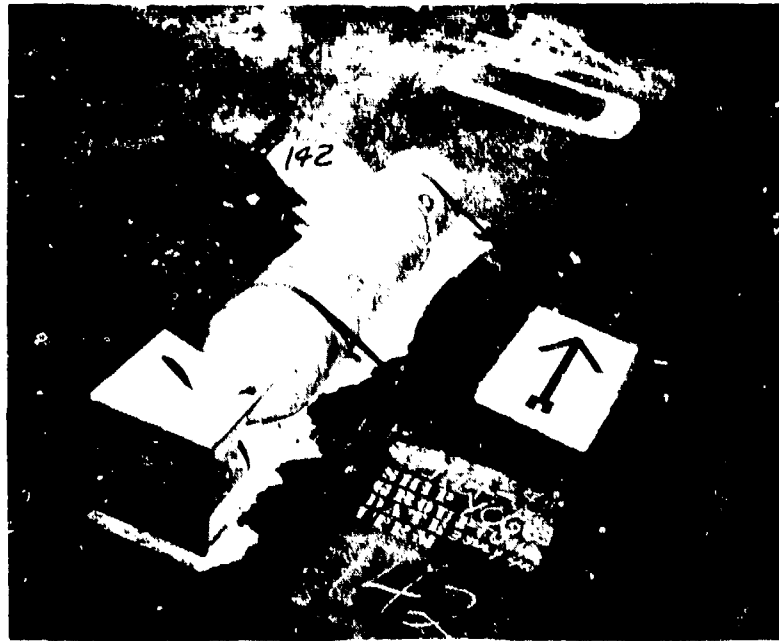
Fig. 401 - YOG 83 - Damage to Item 142 after Test Able.

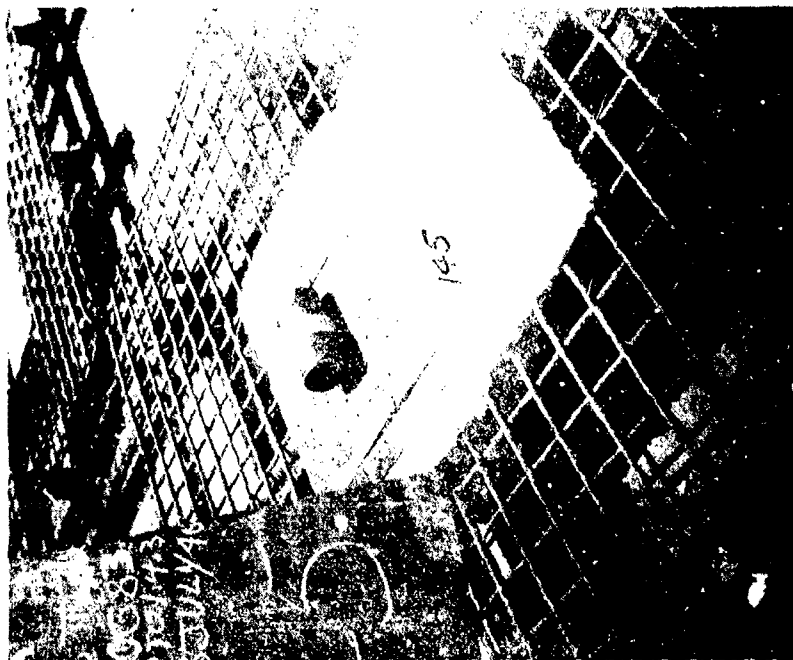
Fig. 408 - YOG 83 - Damage to Item 145
after Test Able.

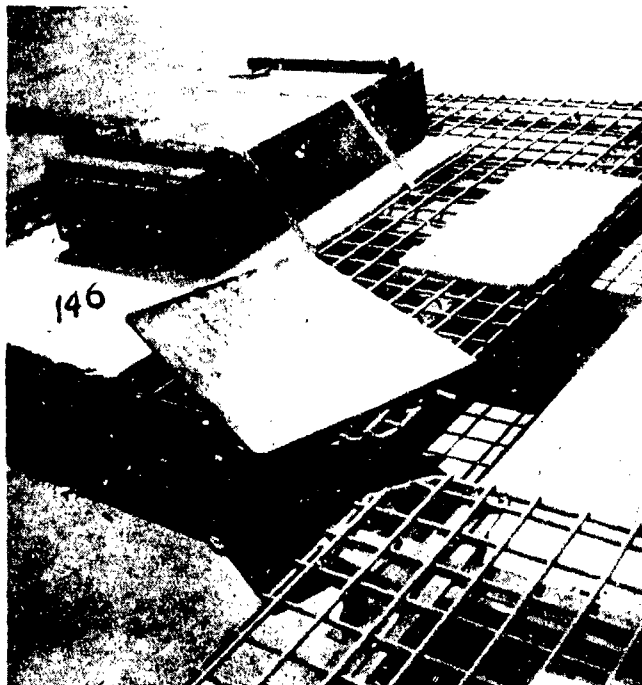
d. Grenade, Hand, Offensive, Mk3A1 (Item #146). Forty-nine were displayed in a wooden box, see Fig. 406. On the YOG 83, see Fig. 407 and Fig. 409, the box was slightly charred on the top, diagonally for a distance of 2-1/2" from the back and end. The box was moved ahead and to the side 1/8". On the LST 52, the box was slightly scorched on the exposed side and top. On the LST 661, the box was slightly scorched, but the markings were still legible. There was no apparent damage on the other ships.

Fig. 409 - YOG 83 - Damage to Item 146
after Test Able.

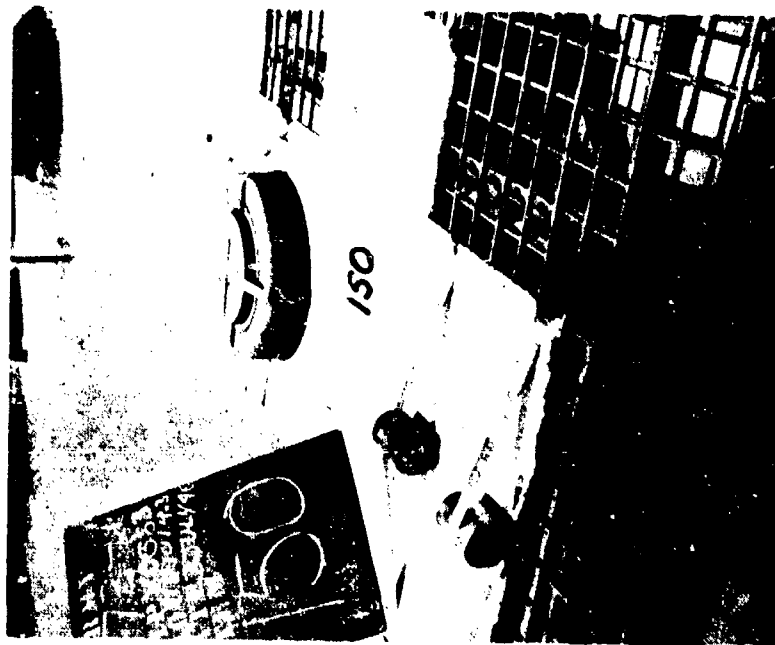
d. Mine, AT, HE, M6 (heavy) w/Fuze (Item #150). One was displayed bare, see Fig. 413. On the YOG 83, see Fig. 414 and Fig. 415, the fuze can and activator can were slightly scorched on the rear and right side. The mine body was not scorched, but the sealing tape on the activator well was scorched and torn. Evidently some foreign object had been blown across the mine and left scratches on it. On the LST 52, the item was partially masked by the elevator ramp. No primary damage was apparent on this or the remaining ships.

Fig. 415 - YOG 83 - Damage to Item 150
after Test Able.

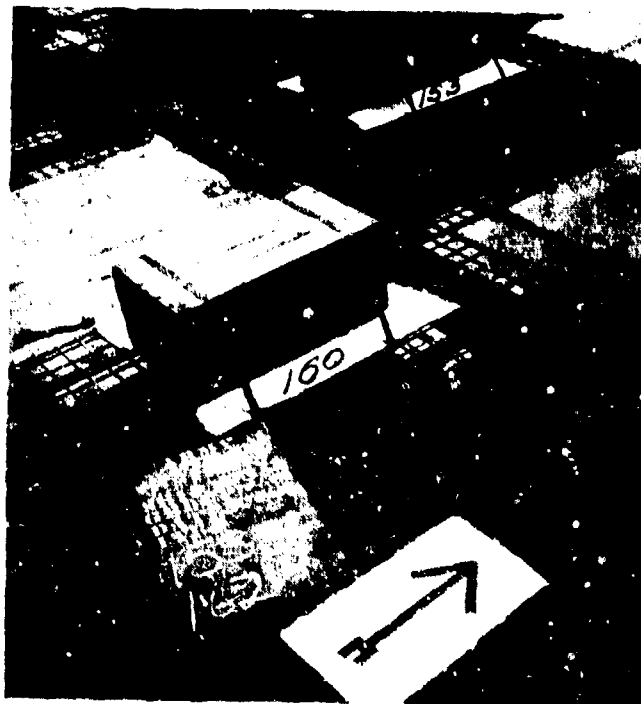
g. Mine, AT, HE, M4, w/o Fuse (Item #153). Four mines were displayed in a wood box, see Fig. 420. On the YOG 83, see Fig. 421, one end and the back were excessively charred. The stencilling on the side and rear was charred. The bottom of the box was splintered and the side of the box had pulled away about 3/16" at one end. Masking marks made by the strapping were clearly visible. On the LST 52, the box was scorched on the exposed side. On the LST 661, the box was lightly scorched. No damage was apparent on the other ships.

Fig. 421 - YOG 83 - Damage to Items
153 and 160 after Test Able.

g. Block, Demolition, TNT, 1/2 lb. (Item #160). Four blocks were displayed in a wood box, see Fig. 430. On the YOG 83, see Fig. 431, the box was charred extensively on one side and end. A shipping tag on the end was undamaged while the wood was charred around it. On the LST 52, the box was scorched on the sides toward the blast. No damage was apparent on the remaining LSTs.

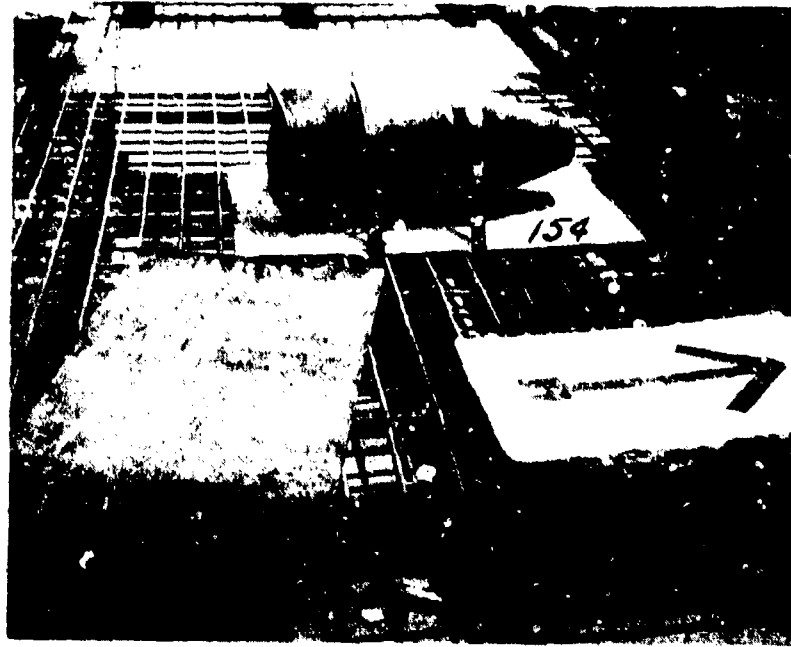
a. Charge, Shaped, 15 lb., M2A3 (Item #154). One was displayed bare, see Fig. 422. On the YOG 83, see Fig. 414 and 423, the inside wall of the stand-off, on the side nearest the blast, was scorched from the outer edge inward about 3". On the side away from the blast, the inside walls were charred. Fifty percent of the outside walls were charred. Fifty percent of the outside walls of the body of the charge were charred. The stand-off and ogive were charred in the upper quadrant on the side nearest the blast. Mask marks made by a loop of the carrying strap as well as the metal tie-down straps were clearly visible on the body of the charge. No markings remained on the charge on the LST 52, see Fig. 424. The charge was dented by the tie-down straps for approximately 180°. The body of the charge was scorched on the side exposed to the blast. On the LST 661, the charge was slightly scorched on the side nearest the blast. It had been partially masked by a winch. No damage was apparent on the LST 220 and LST 545.

Fig. 423 - YOG 83 - Damage to Item 154 after Test Able.

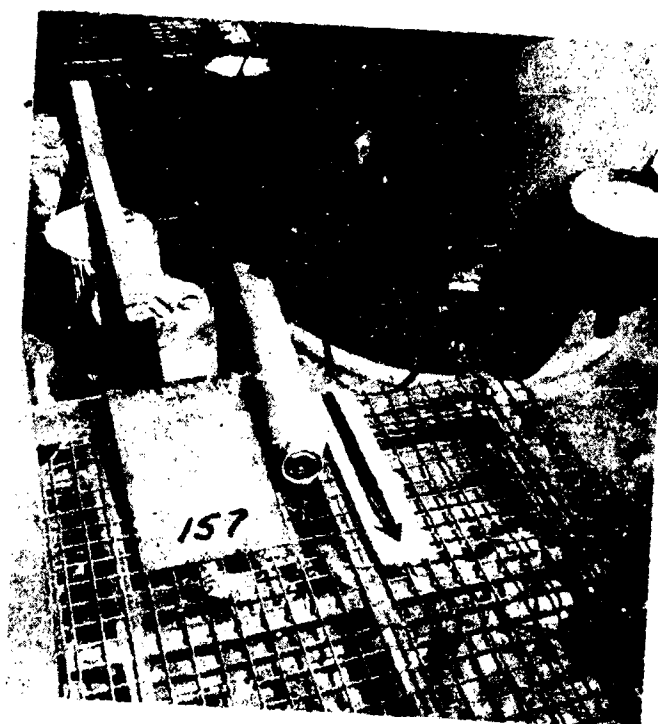
d. Cartridge, Snake, Demolition, M3 (Item #157). One was displayed bare, see Fig. 426. On the LST 52, see Fig. 427 and Fig. 428, the cartridge was blown from the pallet onto the port side of the deck. There was no damage incurred other than superficial dents in the casing. No damage was apparent on the other ships.

Fig. 428 - LST 52 - Damage to Item 157
after Test Able.

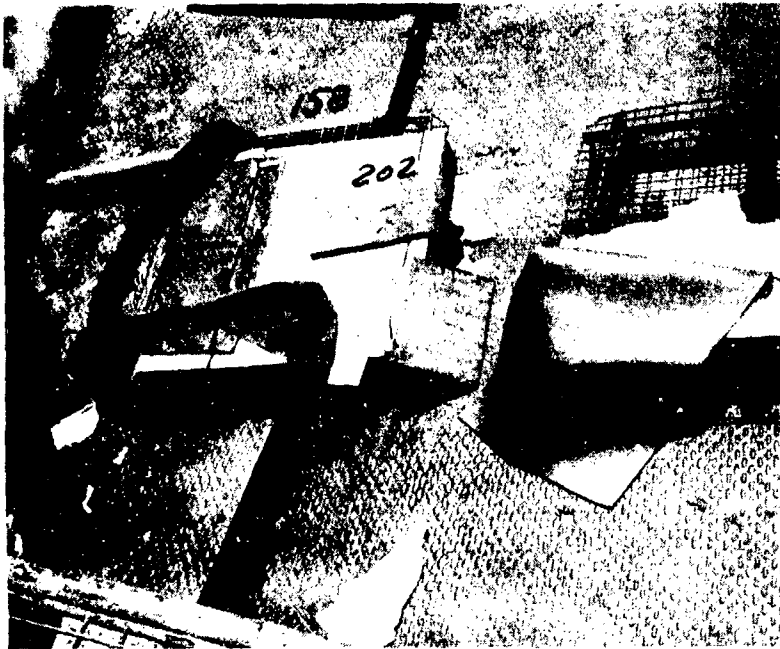
e. Cartridge, Snake, Demolition, M3 (Item #158). One was displayed in a box, see Fig. 426. On the LST 52, see Fig. 427 and Fig. 429, the cartridge was displayed on the ship's elevator which was disturbed by the blast and left suspended between the tank and weather decks. The damage to the cartridge consisted of dents in the casing. It was blown from its box and landed on an elevator ramp. There was no apparent damage on the remaining ships.

Fig. 429 - LST 52 - View after Test Able showing the displacement of Item 158 and damage to Item 202.

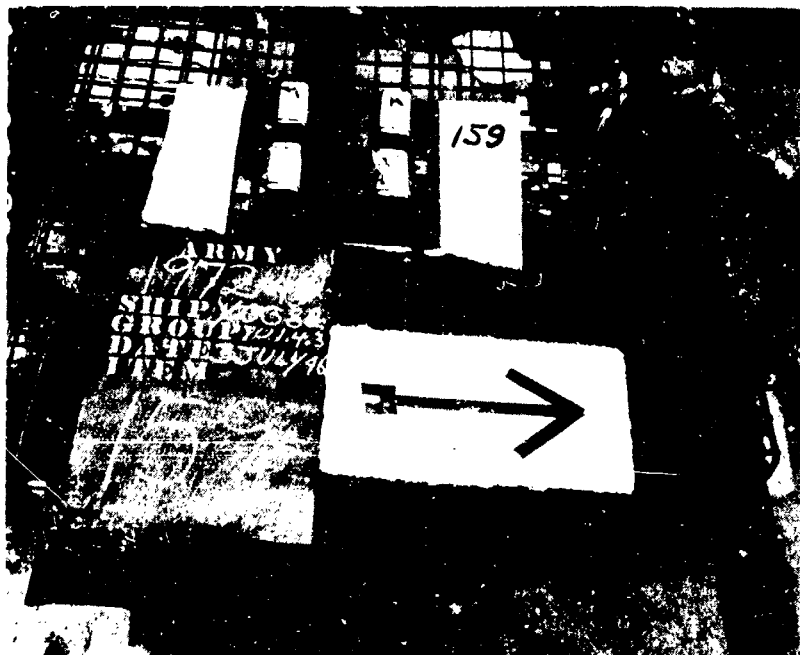
f. Block, Demolition, TNT, 1/2 lb. (Item #159). Four blocks were displayed bare, see Fig. 430. On the YOG 83, see Fig. 431 and Fig. 432, the paper covering was slightly charred and ripped by the blast. There was no apparent damage to the TNT itself. On the LST 52, the item was scorched on the exposed side. The outside skin of paper on one block was burned off on the side facing the blast. No damage was apparent on the other target ships.

Fig. 432 - YOG 83 - Damage to Item 159 after Test Able.

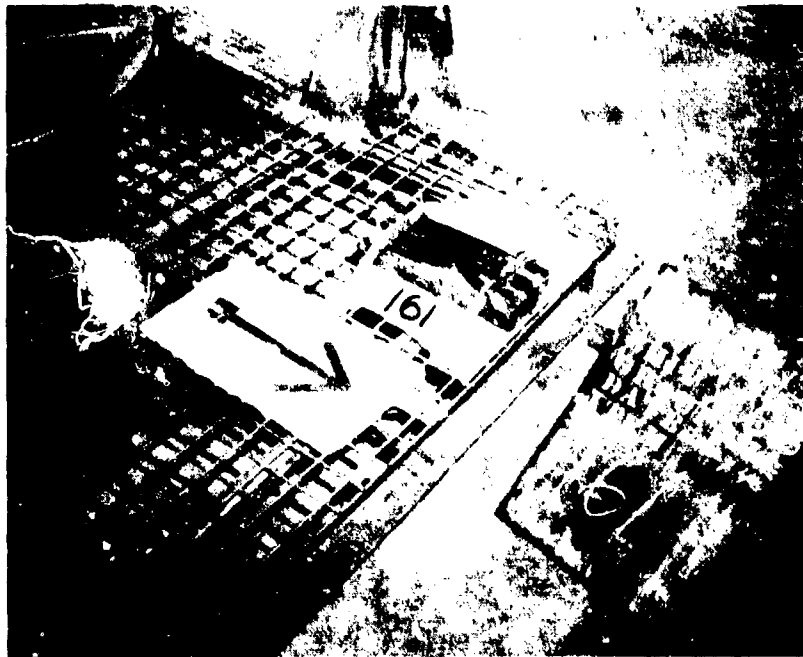
h. Block, Demolition, M2, 2-1/2 lb. (Item #161). Two were displayed bare, see Fig. 433. On the YOG 83, see Fig. 434 and Fig. 435, the chipboard covering was scorched and ripped extensively. The cardboard on the upper edge of the block had been burned away over an area of about 4 inches. The block was broken and the explosive was badly scorched. The fuse well covering on one of the blocks was badly scorched. The outside layer of the covering on the top and sides was charred and blown away. The markings were obliterated on the top and one side while those on the other side were partially legible. On the LST 52, see Fig. 436, the paper covering was partially burned off and the tetrytol charge was scorched on the exposed side. Before Test Able, the paper seal was missing on the fuse well. On the LST 661, the item was partially masked by the ramp. There was no damage apparent on the remaining ships.

Fig. 435 - YOG 83 - Damage to Item 161 after Test Able.

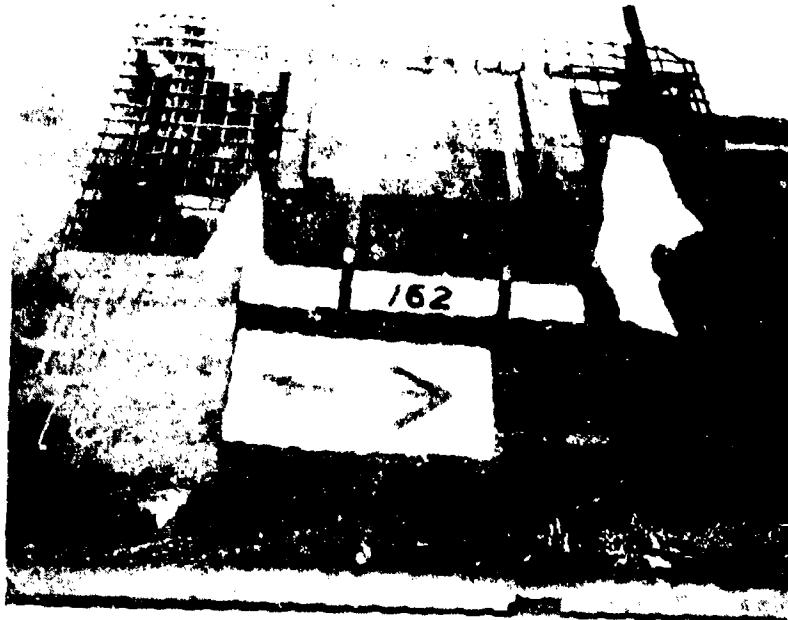
i. Block, Demolition, M2, 2-1/3 lb. (Item #162). Two were displayed in a wooden box, see Fig. 437. On the YOG 83, Fig. 438 and Fig. 439 the top and end were charred extensively. The cleats on the lid were also charred. The rope handle was scorched and the markings were obliterated on both side and rear. On the LST 52, see Fig. 436, the box was scorched on the blast side. On the LST 661, the box was partially masked by an elevator ramp. There was no apparent damage on the other ships.

Fig. 439 - YOG 83 - Damage to Item 162 after Test Able.

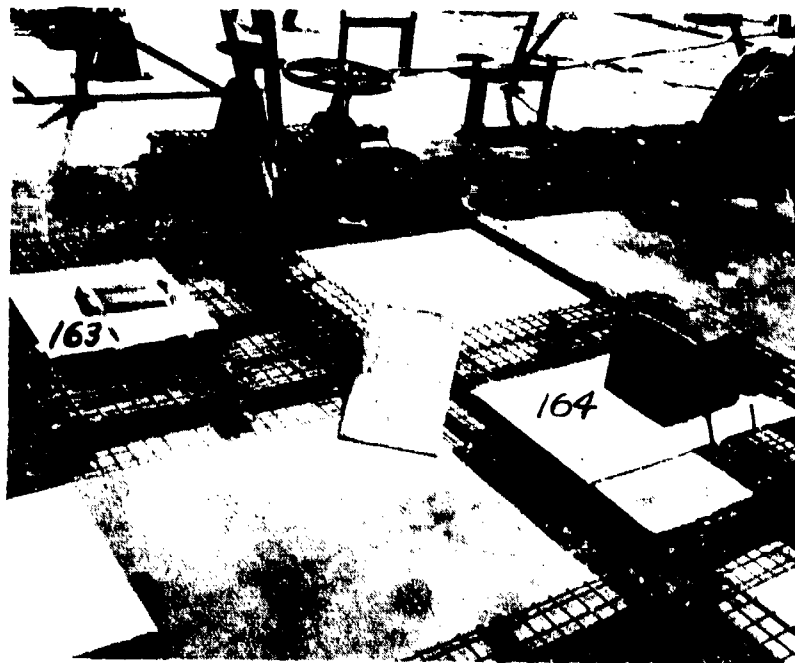
j. Block, Demolition, M3, 2-1/4 lb. (Item #163). Two were displayed bare, see Fig. 440. On the YOG 83, see Fig. 438 and Fig. 441, the cartons were crushed in strapping them to the pallet. The cardboard packing was scorched and torn and the markings were obliterated. Composition C3 was oozing out the end and upper corner of one of the blocks. On the LST 52, there was a slight exudate before Test Able. On the LST 661, the blocks were dented by strapping. There was no damage reported on any of the other ships.

Fig. 441 - YOG 83 - Damage to Items 163 and 164 after Test Able.

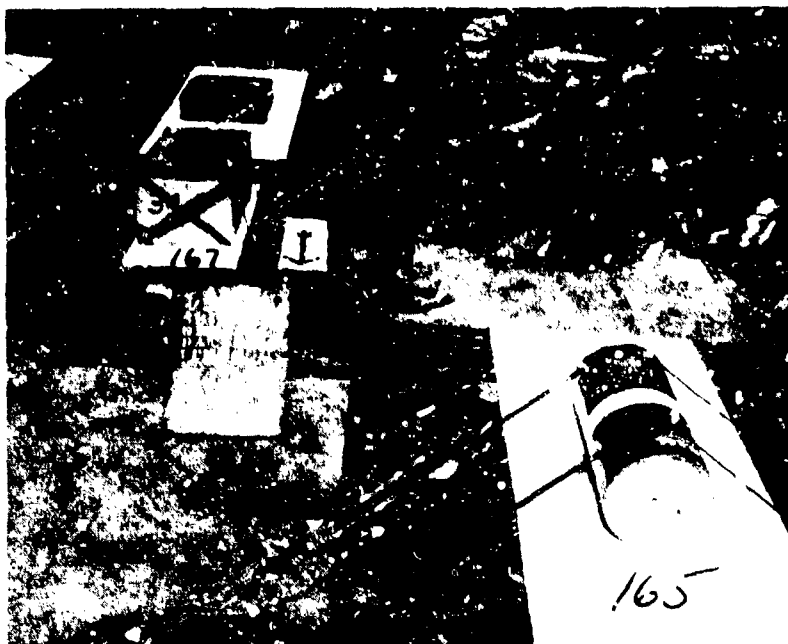
Fig. 443 - YOG 83 - Method of securing Items 165 and 167.

n. Dynamite, 40% (Item #167). Three sticks were displayed in a wood box, see Fig. 449. On the YOG 83, see Fig. 443 and Fig. 450, the top, end, and side of the box towards the bomb were scorched. The markings on these surfaces were obliterated. The side away from the blast was spattered with asbestos. On the LST 52, the box was scorched on the exposed side. No damage was reported on the other ships.

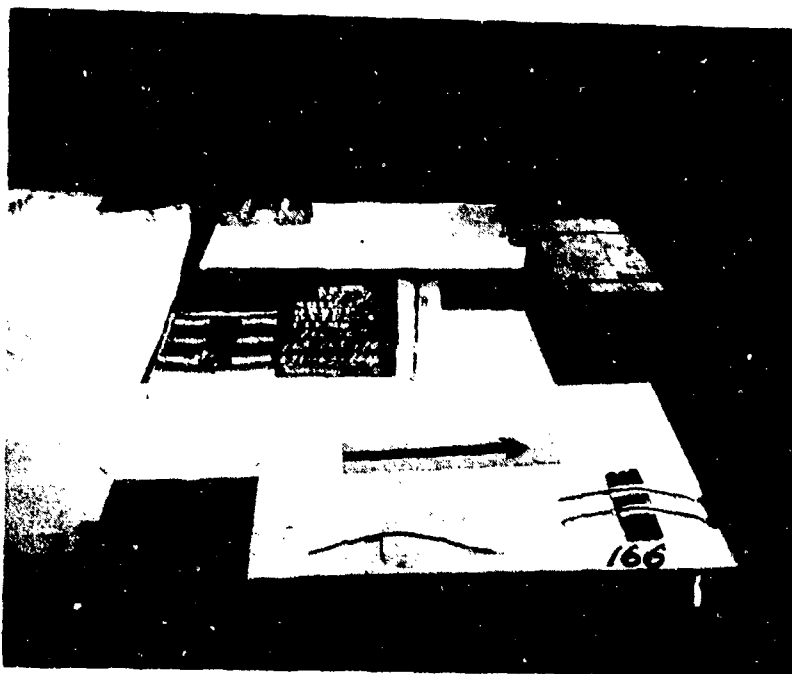
Fig. 445 - LST 52 - Method of securing Item 166.

m. Dynamite, 40% (Item #166). Three sticks were displayed bare, see Fig. 445. On the YOG 83, before the test, see Fig. 446, the paper wrapping on one stick started to open. After Test Able, see Fig. 447, this stick had melted and there was a pool of explosive on the metal plate. The paper wrapping on the other two sticks had been slightly opened. On the LST 52, see Fig. 448: the three sticks were broken in half by the blast and were held together only by the paper wrapping. The dynamite showed signs of decomposition and was therefore disposed of. There was no damage apparent on the remaining ships.

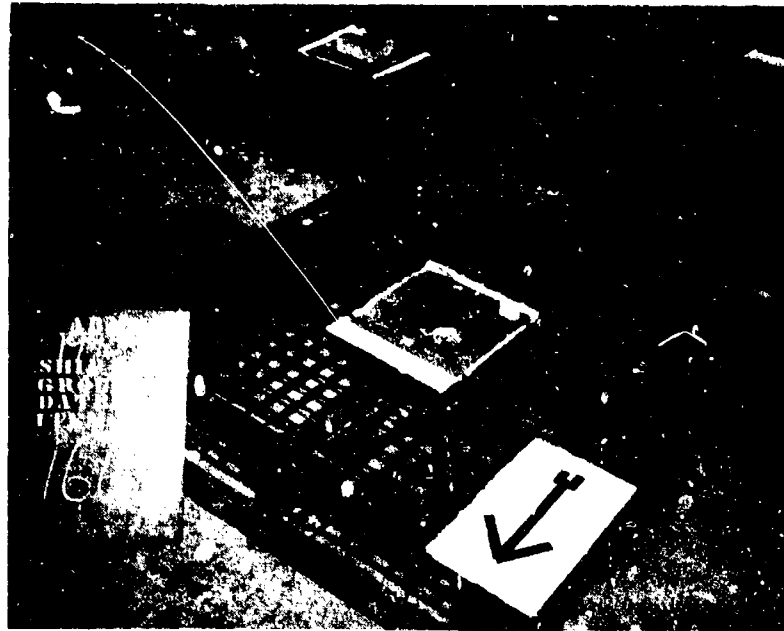
Fig. 447 - YOG 83 - Damage to Item 166 after Test Able.

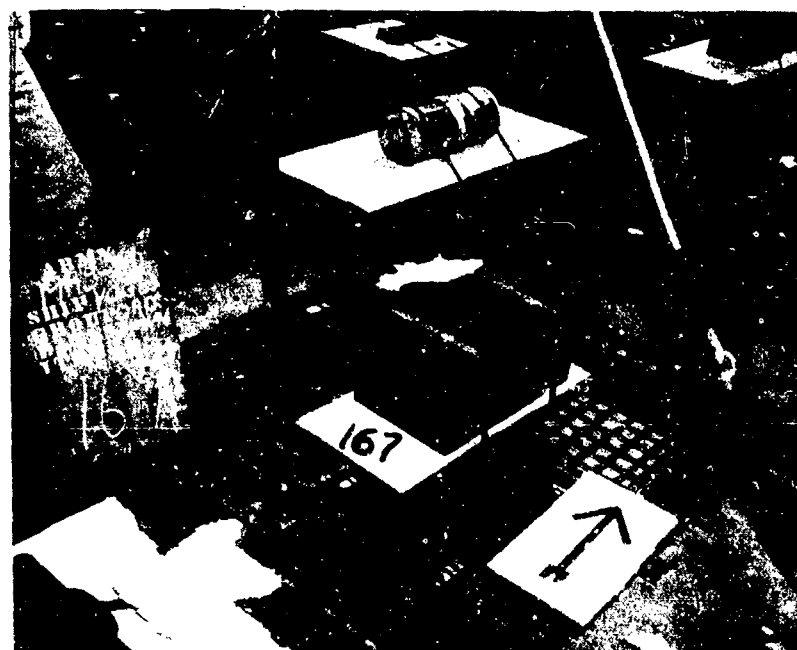
Fig. 450 - YOG 83 - Damage to Item 167 after Test Able.

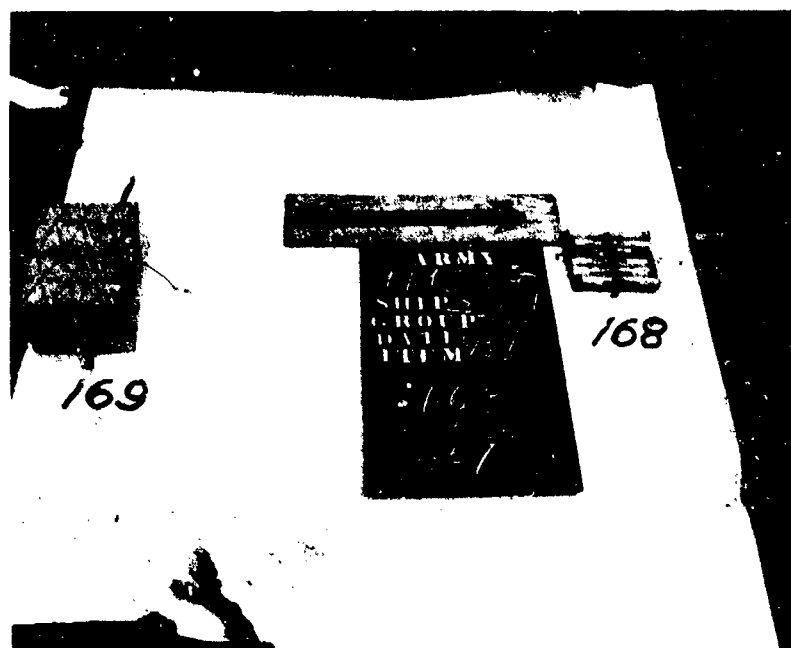
Fig. 451 - LST 661 - Method of securing Items 168 and 169.

o. Cap, Blasting, Electric, #8 (Item #168). Six caps were displayed bare, see Fig. 451. On the YOG 83, see Fig. 452 and Fig. 453, one cap had detonated. Three caps showed evidence of heat and two were in good condition. The wires showed evidence of scorching and all of the shunts were blown off. The two caps which were in good condition were well covered by their lead wires so that the wires protected the caps from the heat. On the LST 52, the paper tubes covering the wires and caps were scorched on the ends. There was no damage to the wires or caps. No damage to this item was evident on any of the other ships.

p. Cap, Blasting, Electric, #8 (Item #169). Twelve caps were displayed in a paper box, see Fig. 451. On the YOG 83, see Fig. 454 and Fig. 444, the paper box was scorched on the top, end, and side. There was no damage to the item on any of the four remaining ships.

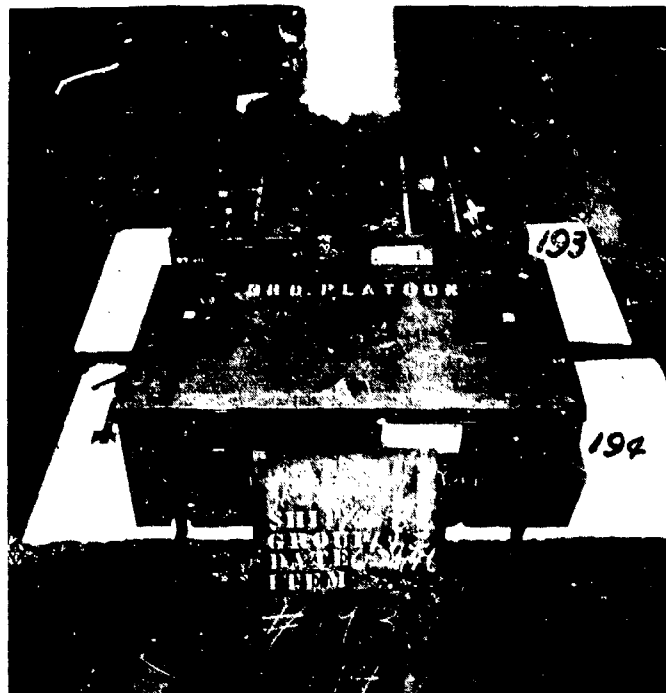
Fig. 462 - YOG 83 - Method of displaying
Items 193 and 194.

m. Set, Demolition, No. 2, Engr. Platoon, Complete, w/o explosives (Item #193). One set was displayed with the lid of the chest open, see Fig. 461. On the YOG 83, see Fig. 462, Fig. 463, and Fig. 464, the top was blown 19 feet forward from the chest and landed upside down. The exposed end of the chest was scorched slightly. No damage occurred to the items in the chest. On the LST 52, see Fig. 465, the chest was scorched on the end and the lid was closed violently by the blast, fracturing the plastic case containing the galvanometer. On the

X. Set, Demolition, No. 2., Engr. Platoon, Complete, w/o explosives (Item #149). One set was displayed in the closed chest, see Fig. 461. On the YOG 83, see Fig. 462 and Fig. 463, the items were not visibly damaged by the blast. The box was scorched on the end and rear but the markings were still legible. The marks made by the strap-ping were clearly visible. On the LST 52, the chest was scorched and the straps were broken. No damage was reported on the other ships.

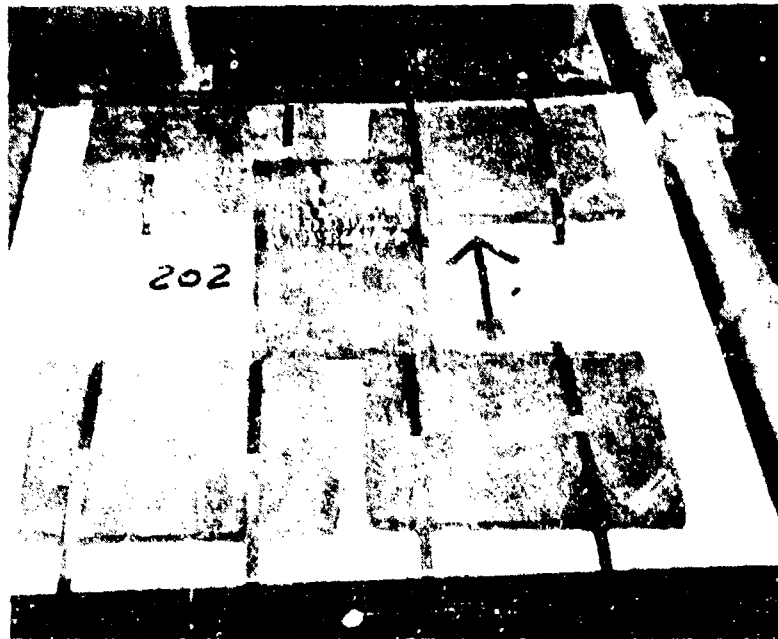
Fig. 467 - YOG 83 - Method of securing Item 202.

c. GR-S Rubber (Item #202). Four sheets were displayed. On the YOG 83, Fig. 467 and Fig. 468, one of the sheets apparently was blown over the side, the other three remained at the display. The samples retained their color but were slightly charred. They were still spongy, soft, and retained their characteristic odor. On the LST 52, Fig. 469, Fig. 429, and Fig. 470, three pieces were displayed. One of these was not recovered and apparently had been lost over the side. No damage was incurred by the two remaining pieces. There was no apparent damage on the other three ships.
